# Polycom<sup>®</sup> RMX<sup>®</sup> 1500/2000/4000 Release Notes

This document provides the latest information for security-conscious users running Version 7.6.1 software. The information in this document is not intended to imply that DoD or DISA certifies Polycom RMX systems.

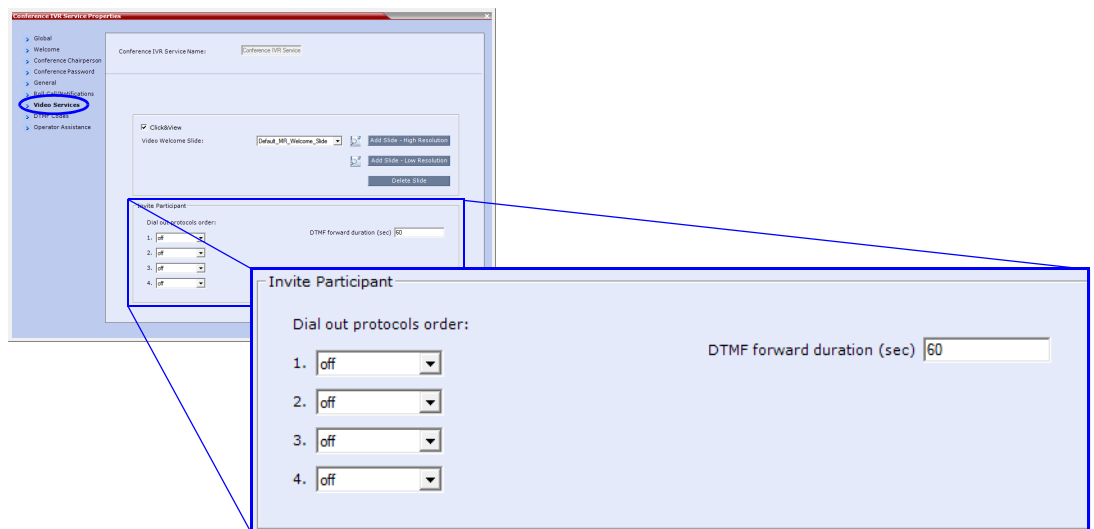
A new pane, *Invite Participant*, has been included in the *New Conference IVR Service* and *IVR Service Properties - Video Services* dialog boxes.

- *Dial out protocol order*  
Selects the order of the network protocols that will be used by the system to dial the destination number.
- *DTMF forward duration (sec)*  
Sets the number of seconds that the system will wait for the input of additional DTMF digits such as a password or conference number.

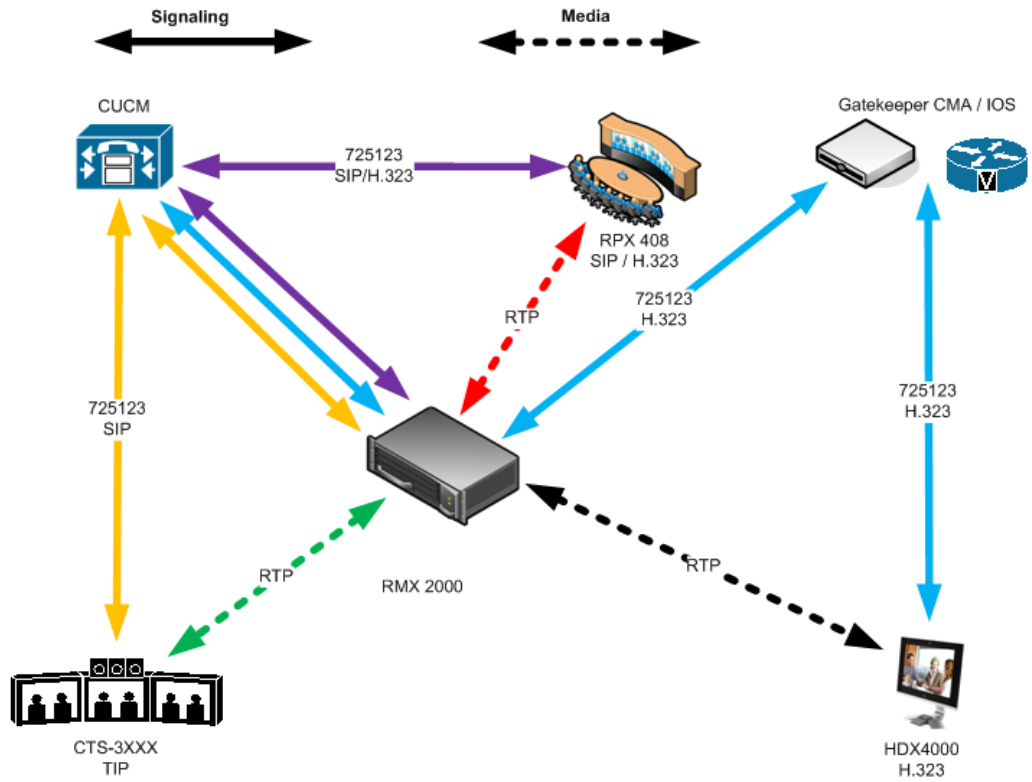
## Multipoint call without DMA

In this example:

- *RMX* prefix in the gatekeeper 72
- *CUCM* According to its *Dial Plan* forwards calls with prefix 72 to the *RMX*

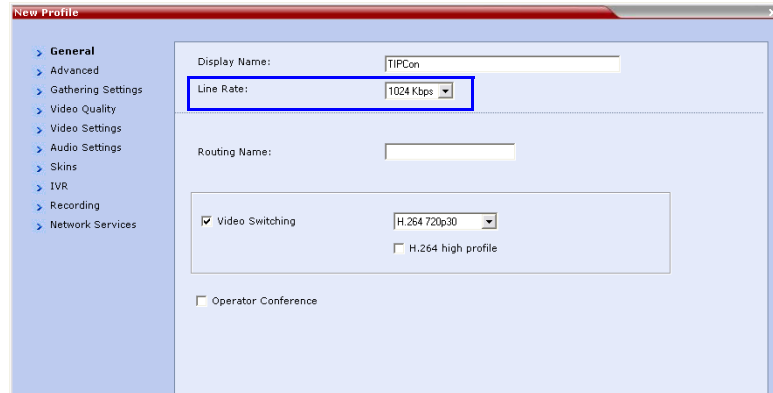
- 1 Create a *New Profile* for the *Meeting Room*. For more information see the *RMX 2000/4000 Administrator's Guide*, "Defining a CP Conference Profile" on page 2-11.
- 2 In the *New Profile - General* tab, set the *Line Rate* to a value of at least that specified for the **MIN\_TIP\_COMPATIBILITY\_LINE\_RATE** System Flag in Procedure 1.

The screenshot shows the 'New Profile' configuration window with the 'General' tab selected. The 'Line Rate' dropdown menu is highlighted with a blue box and set to '1024 Kbps'. Other visible settings include 'Display Name: TIPCon', 'Routing Name', 'Video Switching' (checked, H.264 720p30), and 'Operator Conference' (unchecked).

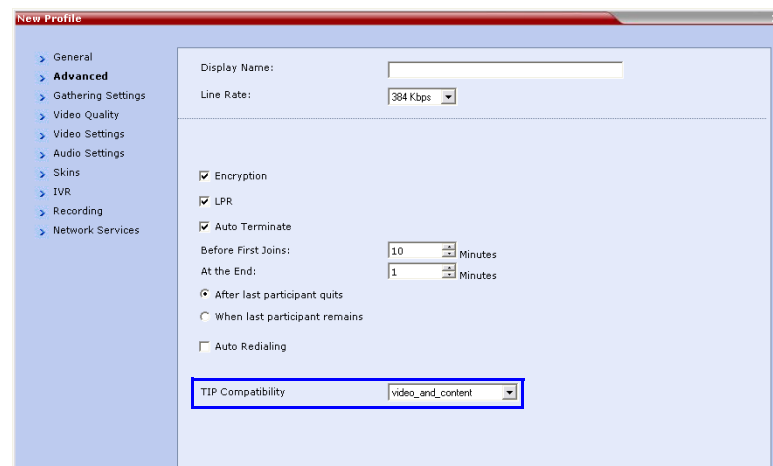
The screenshot shows the 'New Profile' configuration window with the 'Advanced' tab selected. The 'Line Rate' dropdown menu is set to '384 Kbps'. The 'TIP Compatibility' dropdown menu is highlighted with a blue box and set to 'video\_and\_content'. Other visible settings include 'Encryption', 'LPR', 'Auto Terminate', and 'Auto Redialing'.

- 4 Select the *TIP Compatibility* mode. The *TIP Compatibility* mode affects in the user *Video* and *Content* experience as described in the following table.

Selecting *TIP Compatibility* as **Video and Content** disables *Content Settings* in the *Video Quality* tab.

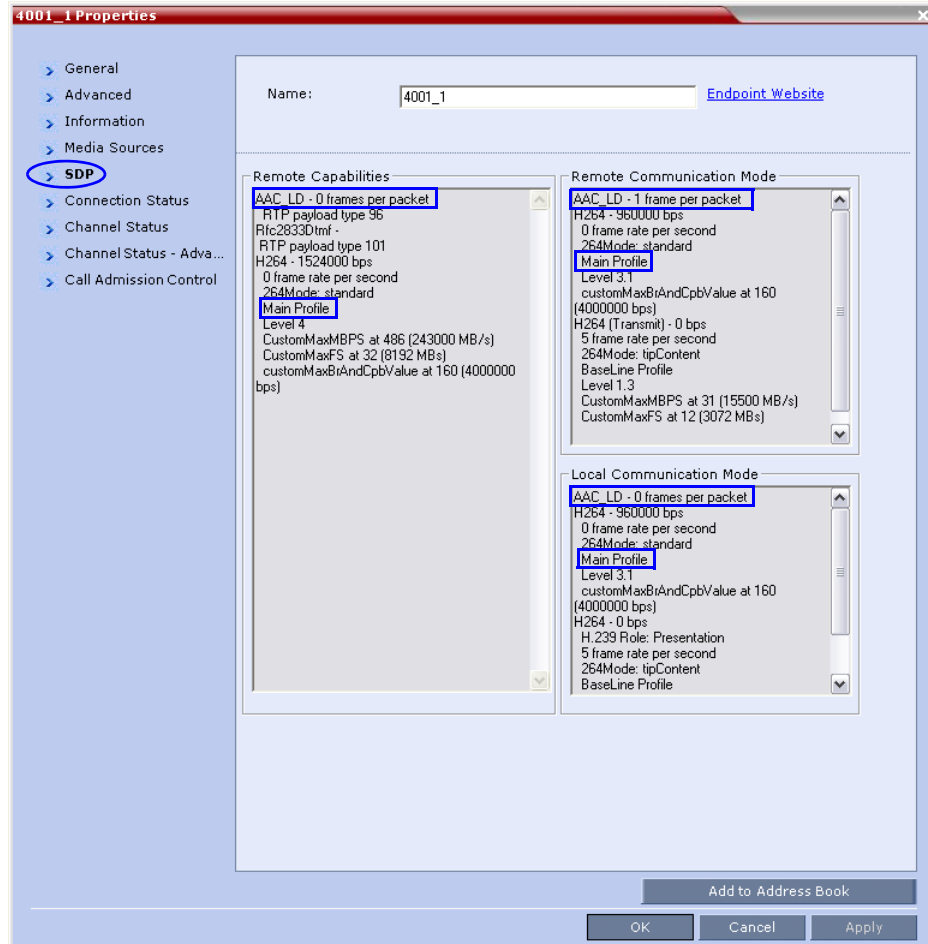
The following are indicated in the *Remote Capabilities*, *Remote Communication Mode* and *Local Communication Mode* panes:

- AAC\_LD - Audio Protocol
- Main Profile - Video protocol

The CTS Audio Auxiliary channel is used only for Content. In all other cases, the bit rate shown in the *Properties - Channel Status* dialog box for this channel is 0.

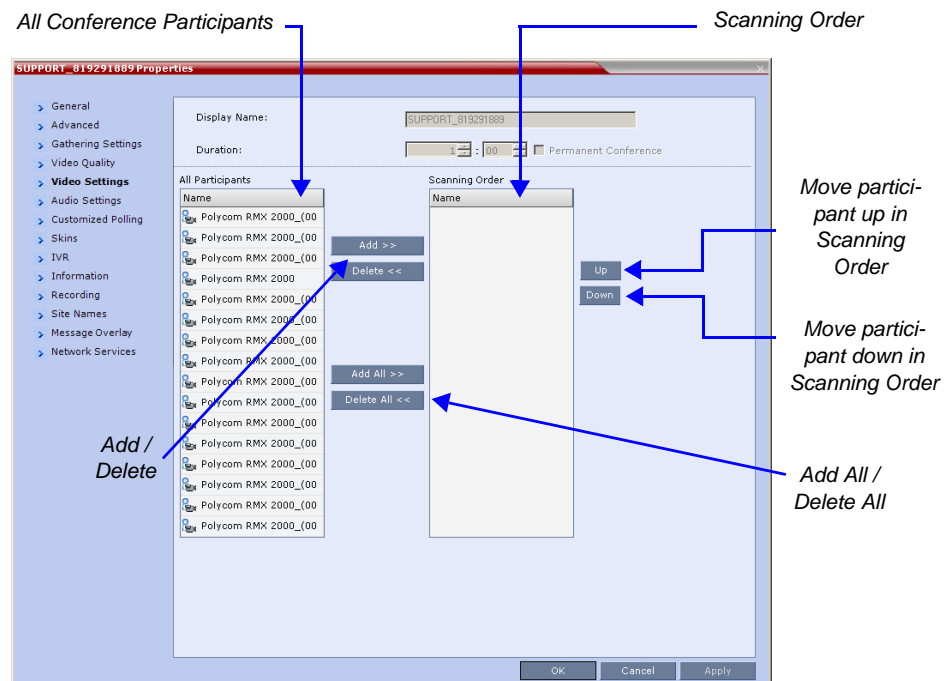
- 1 Open the *Customized Polling* tab:
  - a If the *Video Settings* tab is open click the **Customized Polling** tab.
  - or
  - b In the *Conference* list pane, double-click the conference or right-click the conference and then click **Conference Properties**.
  - c In the *Conference Properties - General* dialog box, click **Customized Polling**. The *Customized Polling* tab is displayed.

All conference participants are listed in the left pane (*All Participants*) while the participants that are to be displayed in the Auto Scan enabled cell of the video layout are listed in the right pane (*Scanning Order*).

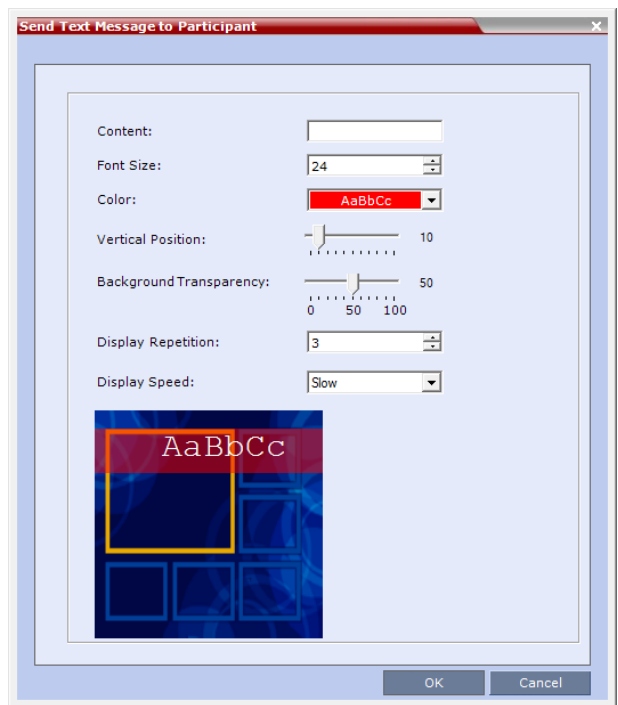
MPMx Card Mode

The *Send Text to Participant* window is displayed.

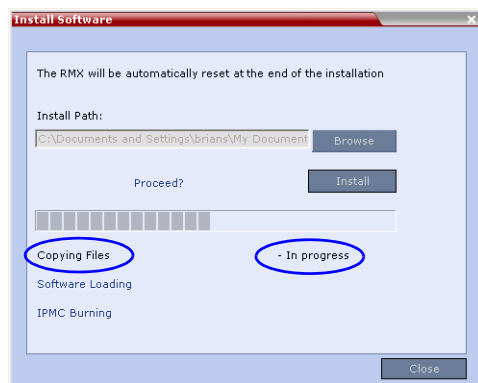
At the start of 7.6/7.6.1 software upgrade/downgrade procedure, the *Install Software* information box appears showing that the file copy is *In progress*.

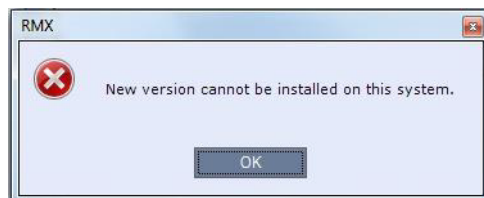
When a non feasible software version upgrade path is selected, an RMX *Safe Software Version Installation* dialog box appears.

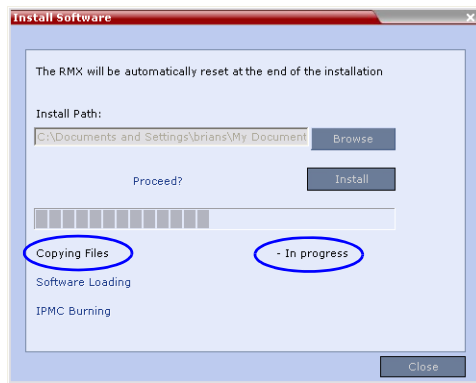
At the start of 7.6/7.6.1 software upgrade/downgrade procedure, the *Install Software* information box appears showing that the file copy is *In progress*.

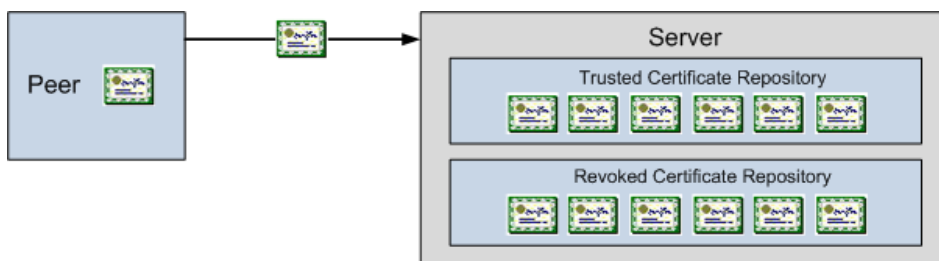
The diagram below illustrates the peer certificate validation procedure.

- The credentials of each certificate received from a networked peer are verified against a repository of trusted certificates. (Each networked entity contains a repository of trusted certificates.)
- The digital signature of the certificate's issuing authority is checked along with the certificate's validity (expiration date).

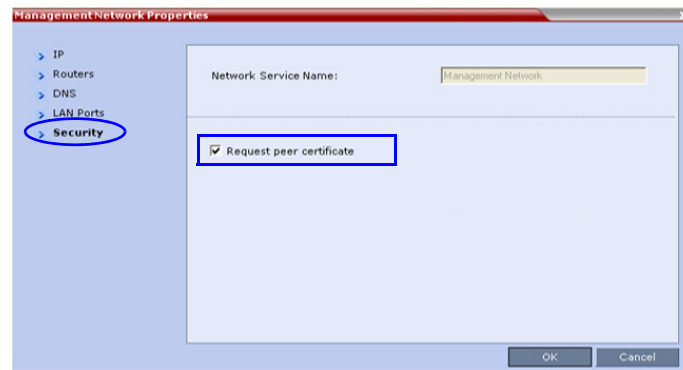
- 1 In the *RMX Management* pane, click the **IP Network Services** entry.
- 2 In the *IP Network Services* list pane, double-click the **Management Network** entry.
- 3 Click the **Security** tab.
- 4 Select the *Request Peer Certificate* check box.
- 5 Click the **OK** button.

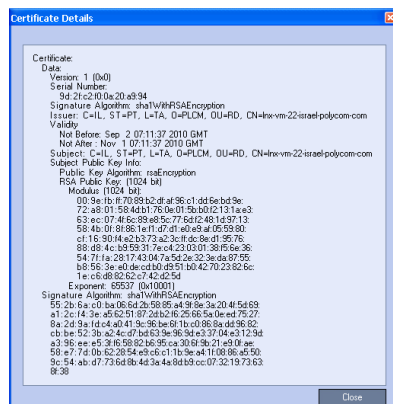
Double-clicking on a certificate in any of the displayed lists, displays the certificate's properties:

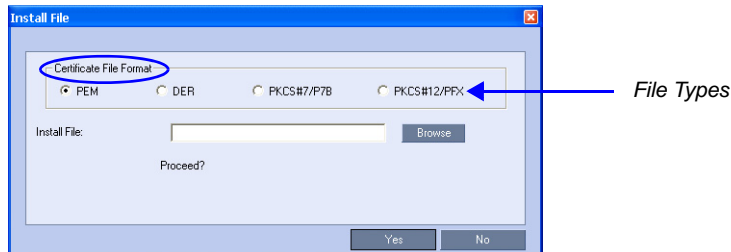
The *Install File* dialog box is displayed.

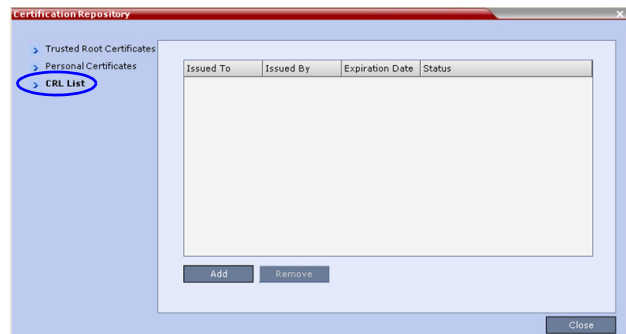
By clicking the column headers the *Certificate Revocation List* can be sorted by:

- **Issued To**
- **Issued By**
- **Expiration Date**
- **Status**

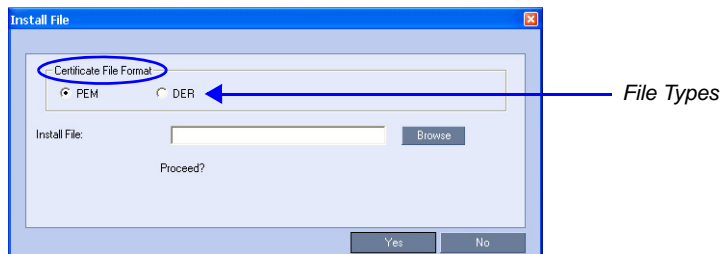
- 1 In the *CRL List* tab, click the **Add** button.
- 2 The *Install File* dialog box is displayed.

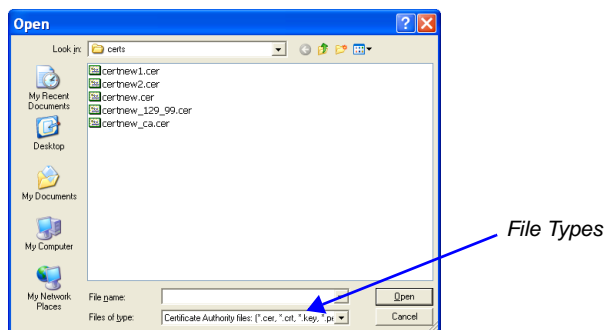
- 3 Select the *Certificate File Format*: *PEM* or *DER*.
- 4 Enter the certificate file name in the *Install File* field or click the **Browse** button.
- 5 The *Open* file dialog box is displayed. The files are filtered according to the file type selected in **Step b**.

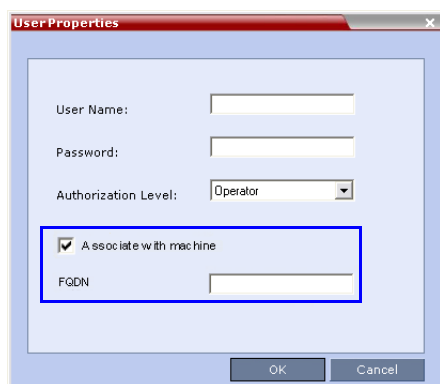
A check box, *Associate with a machine* and a new field *FQDN (Fully Qualified Domain Name)* have been added to the *User Properties* dialog box.

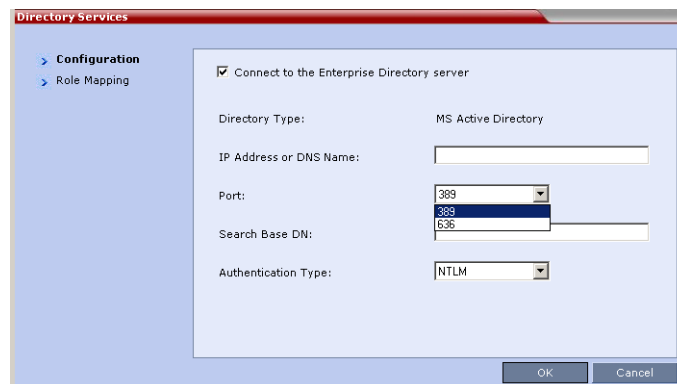
- 1 On the *RMX* menu, click **Setup > Exchange Integration Configuration**. The *Directory Services - Configuration* dialog box is displayed.

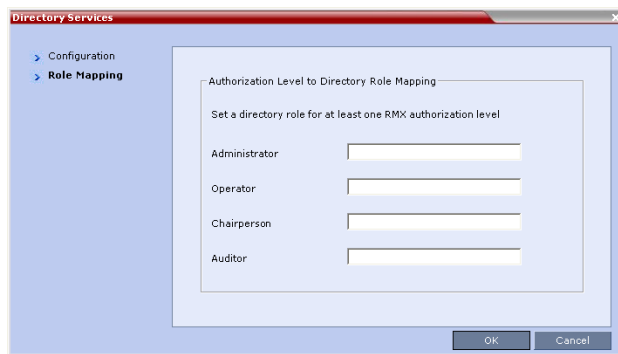
- 3 Click the **Role Mapping** tab.  
The *Directory Services - Role Mapping* dialog box is displayed.

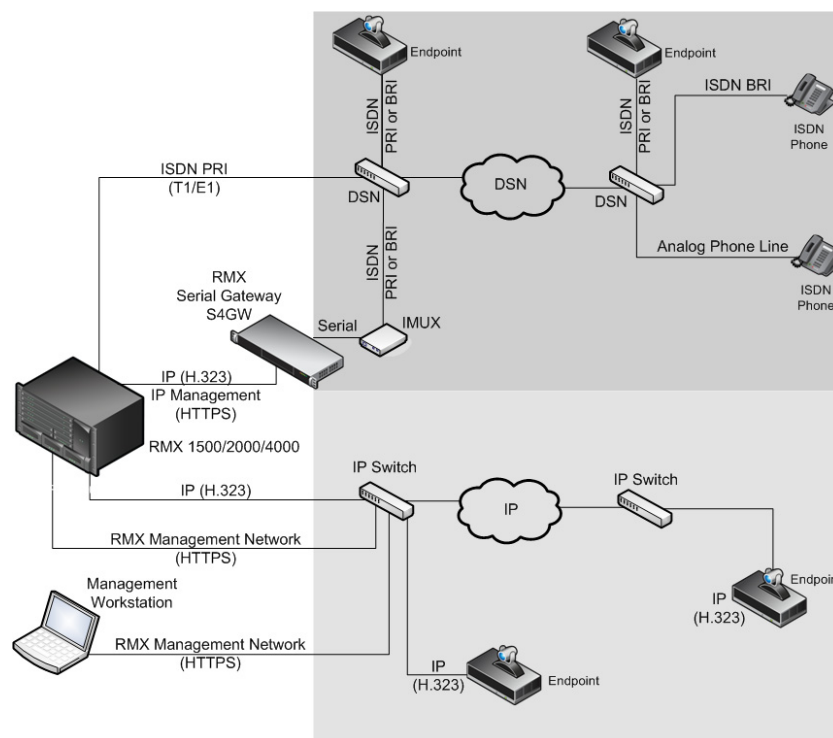
**Figure 1-4** Network infrastructure with direct connection to Serial Gateway S4GW

UC APL Public Key Infrastructure (PKI) requires that the *Serial Gateway S4GW* be connected directly to the *RMX* and not to the *H.323* network. The *Serial Gateway* effectively becomes an additional module of the *RMX*, with all web and *H.323* traffic passing through the *RMX*.

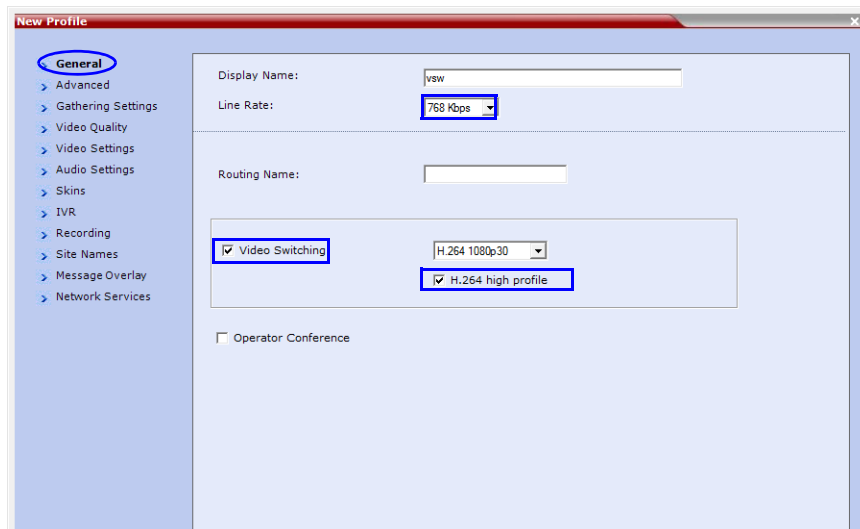
>> Select the *H.264 High Profile* check box, in the *Profiles - General* dialog box.

The *High Profile* check box is only displayed if *MPMx* cards are installed in the *RMX*. By default the *High Profile* check box is not selected. If *H.264* is not the selected video protocol the check box is inactive (grayed out).

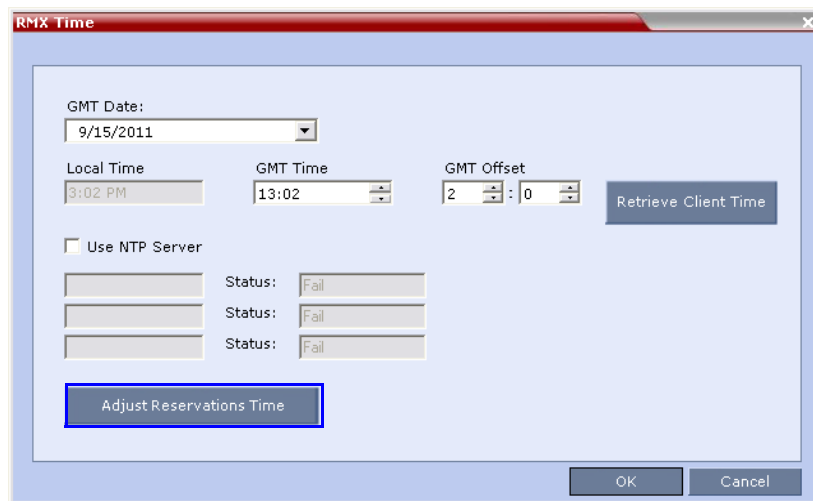
- 1 On the RMX menu, click **Setup > RMX Time**.  
The *RMX Time* dialog box opens.
- 2 Click the **Adjust Reservations Time** button.

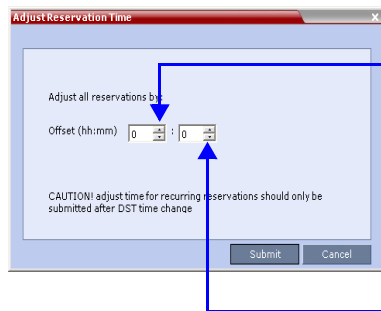
The *Adjust Reservations Time* dialog box opens.

Click the arrows to adjust the start time by hours.  
Range is between 12 hours and -12 hours  
A positive value indicates adding to the start time  
(-) indicates subtracting from the start time

Click the arrows to adjust the start time by minutes.  
Range is between 45 minutes and -45 minutes.  
A positive value indicates adding to the start time  
(-) indicates subtracting from the start time

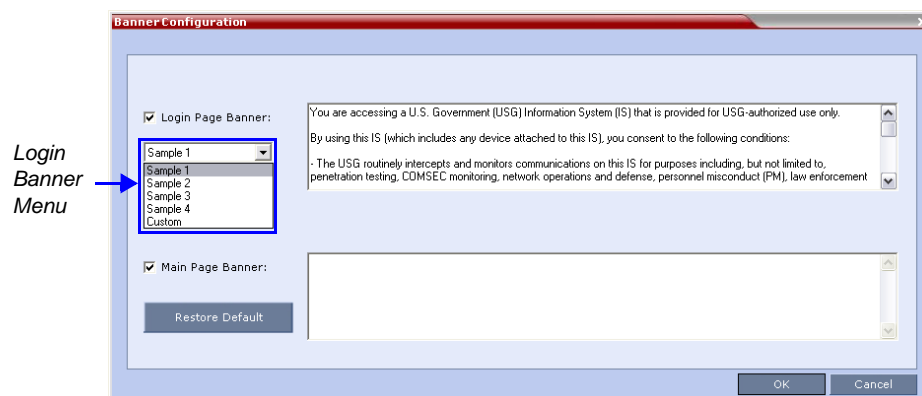
The *Banner Configuration* dialog box allows the administrator to select a *Login Banner* from a drop-down menu.

One of the the following *Login Banners* can be selected:

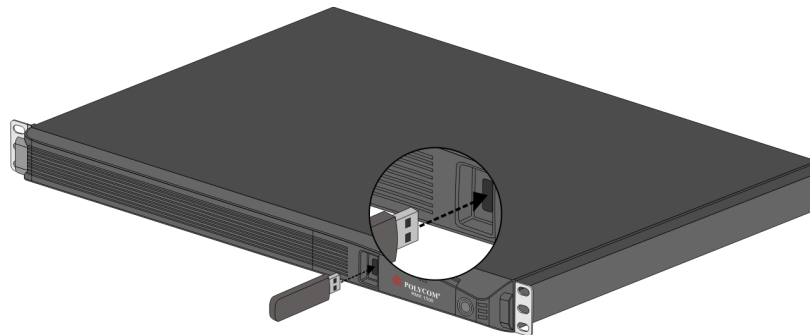
- *RMX 1500* - left most *USB* port on the **front panel**.

When performing *USB Operations*, the following *USB* ports are used:

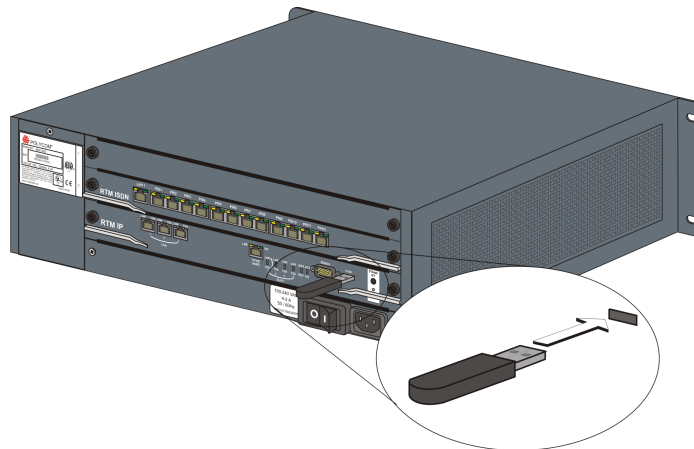
- *RMX 2000* - at the bottom right corner of the *RTM IP* card on the **back panel**.

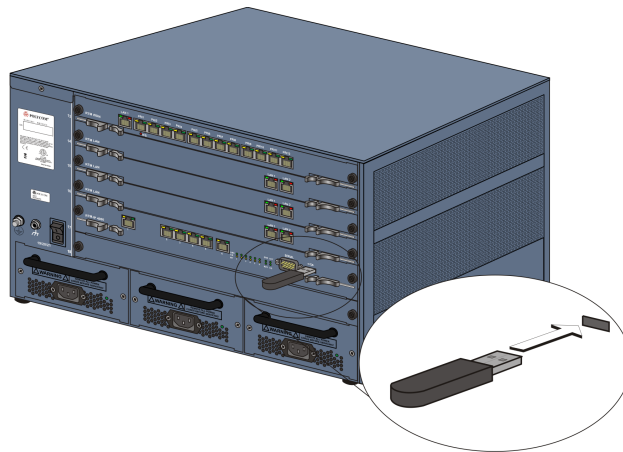
- *RMX 4000* - at the bottom right corner of the *RTM IP 4000* card on the **back panel**.

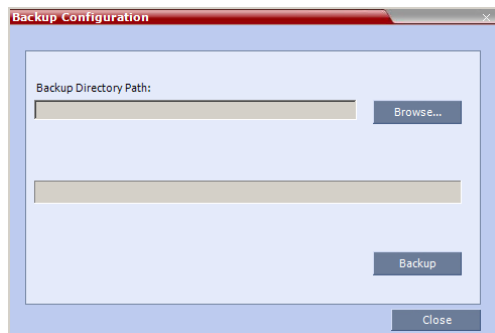
The *Backup Configuration* dialog box opens.

- 2 **Browse** to the *Backup Directory Path* and then click **Backup**.

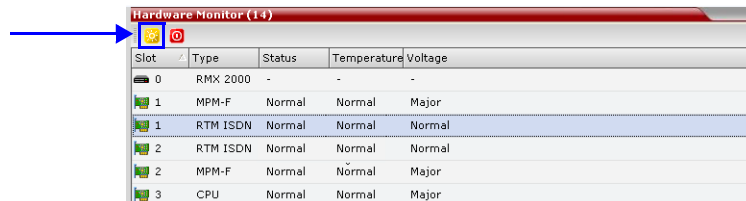
- a Remove the *USB* device that was connected in *Step 2a*.
- b Restart the *RMX*.
- c In the *RMX Management* pane, click the **Hardware Monitor** button.  
The *Hardware Monitor* pane is displayed.

- d Click the **Reset** button.
